# ARBOR VITAE

### Tree Condition Assessment

Survey site: Carnbee, Edinburgh EH16

Date of survey: 5th February 2025

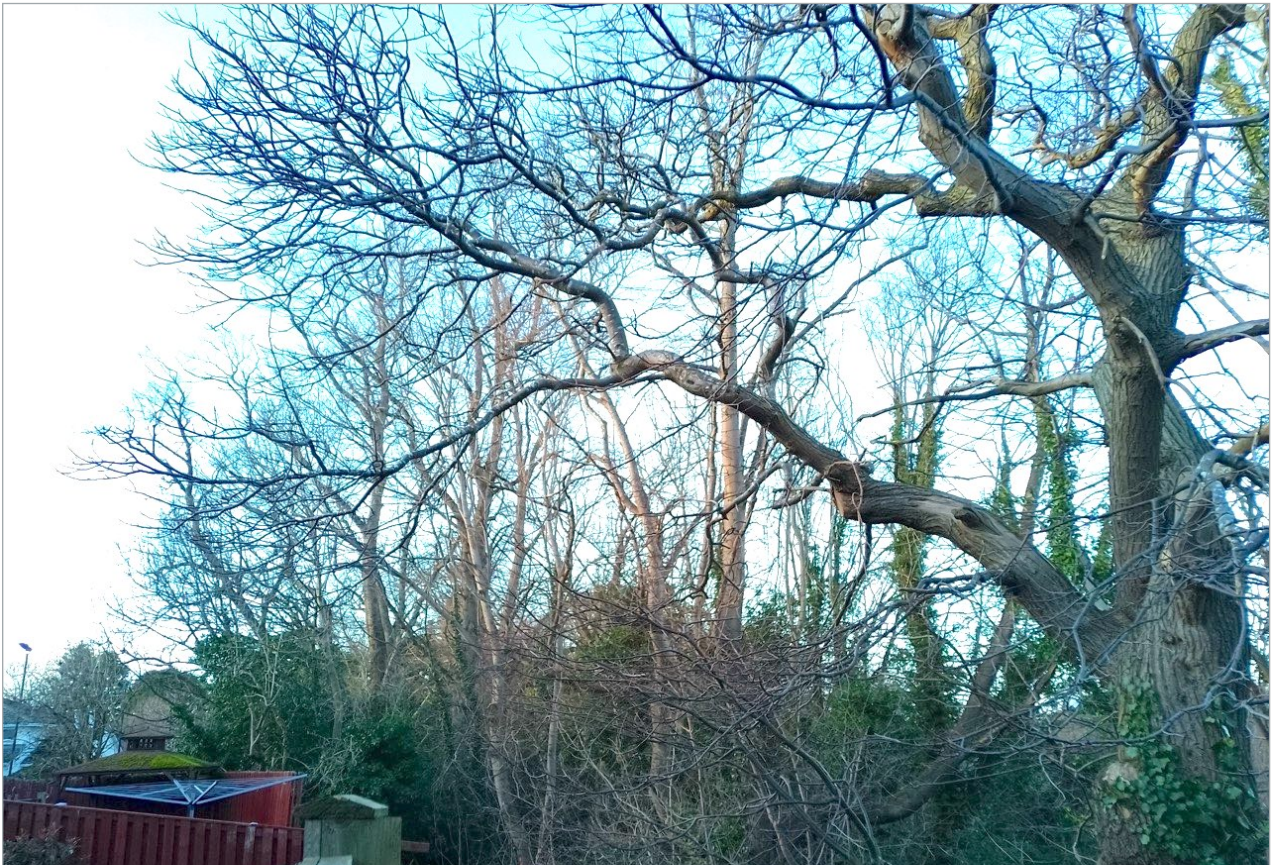
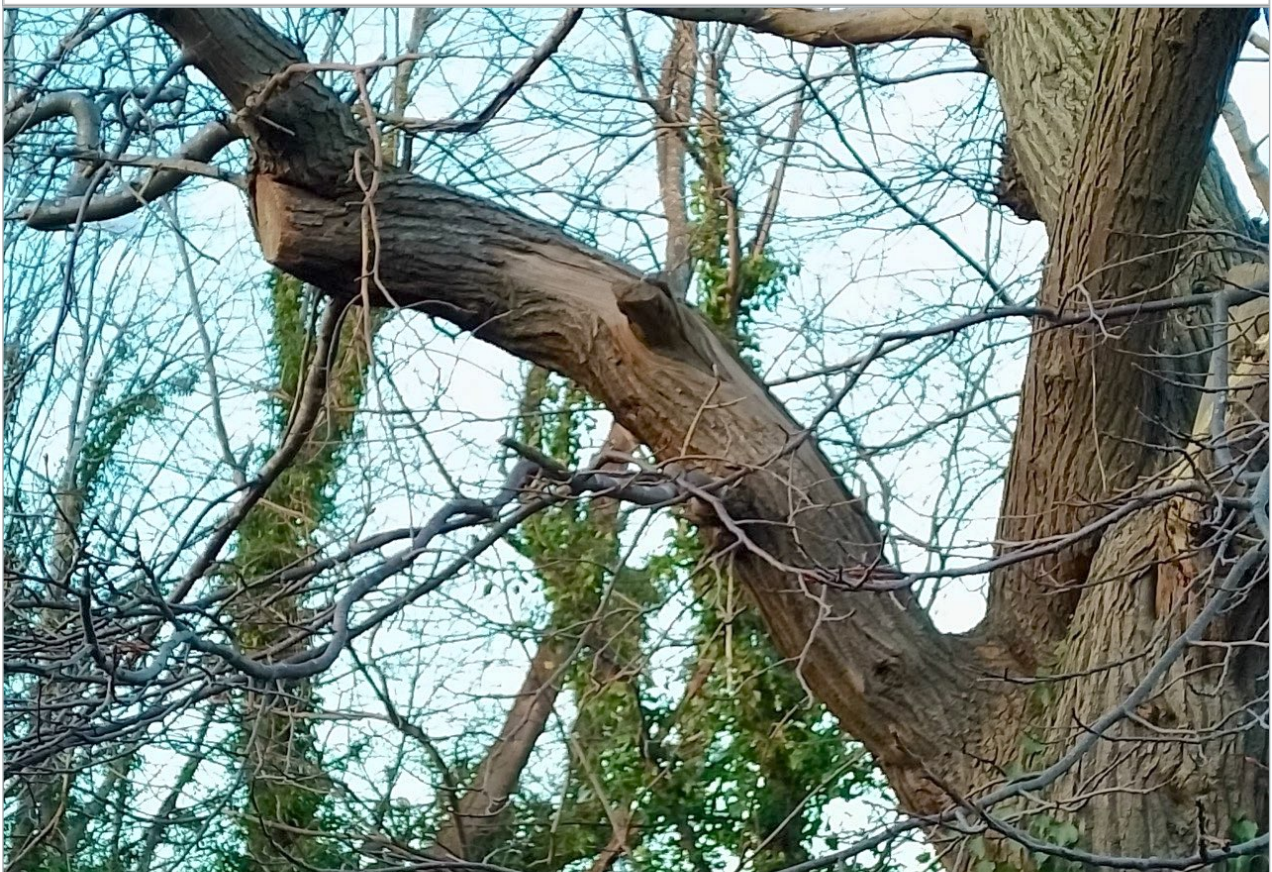
TN	Tag	Species	H	D	AC	V	Condition	Recommendations	U	ERC	RC	Bat	R
60	551	Common Lime ( <i>Tilia europaea</i> )	20	700	M	N	TBD Large wound on a branch at 3SW. The same branch has a large old pruning wound 1m from the main stem. Basal wounds on N and E sides forming a cavity; robust buttresses.	PRUNE; FURTHER INVESTIGATION Reduce the branch at 3SW by around 2 metres length, north of the fence. Sonic tomograph investigation of the lower stem near ground, 0.5 and 1m.	3	TBD	B	P	T
61	552	Common Lime ( <i>Tilia europaea</i> )	24	1100	M	N	TBD Basal assessment impeded by epicormic growth, epicormic stubs and ivy. Visible parts appear to be intact and healthy, except for an eastern buttress that appears to have some decay.	EPICORMIC Carefully remove the epicormic growth and other vegetation before the next assessment.	24	>40	C	P	24
62	553	Common Lime ( <i>Tilia europaea</i> )	25	1000	M	N	MODERATE Slight lean to the north. Large inter-buttress basal cavity to the west with robust wound wood and buttress roots: buttress to the west is intact, buttress to the east has a <i>Kretzschmaria deusta</i> infection. There are 3 or 4 other intact buttress-roots around the stem The stem is otherwise intact with no signs of incipient failure.	NWR	-	>40	A	N	24

**Photos 1 & 2:** A mature Lime (551) has an end-loaded branch with wounding.

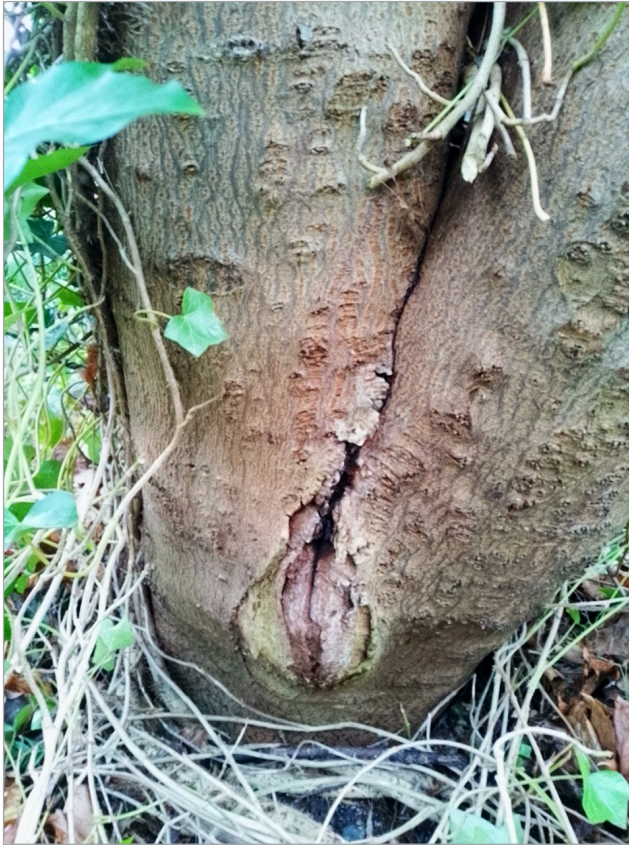
63	NT13	Common Ash ( <i>Fraxinus excelsior</i> )	13	391	EM	N	POOR Included bark union with crack. Could fail onto a conservatory.	FELL Remove the tree.	6	<10	U	N	-
64	NT14	Common Ash ( <i>Fraxinus excelsior</i> )	19	391	EM	N	TBD Included bark unions at 1m but their condition could not be assessed due to dense ivy.	IVY Remove the ivy from the lower stem and assess the main unions.	6	TBD	C	N	6
65	NT15	Norway Maple ( <i>Acer platanoides</i> )	17	346	EM	N	POOR Included bark unions from near ground with no fusion.	FELL Remove the tree.	12	<10	U	N	-

**Photo 3:** Ash (NT13) with an un-fused included bark union.

- 3.1.1 An early-mature Ash and Norway Maple (NT13 & NT15, area 5) have included bark unions with no fusion; this structural defect increases the trees' risk of failure onto people or property (Photos 3 & 4). These trees should be removed. They do not have tag numbers. Both have ivy on their lower stems and are located on the plan.
- 3.1.2 An Elm (2918, area 4) has been marked with an orange cross: this is consistent with City of Edinburgh Council's (CEC) identification for trees to be removed due to Dutch Elm Disease control. Normally the tree owner would be informed in writing that they must remove the tree. I could not see any sign of dieback, however it can be difficult to tell in the winter. It is recommended that the tree owners either contact CEC for confirmation or remove the tree.

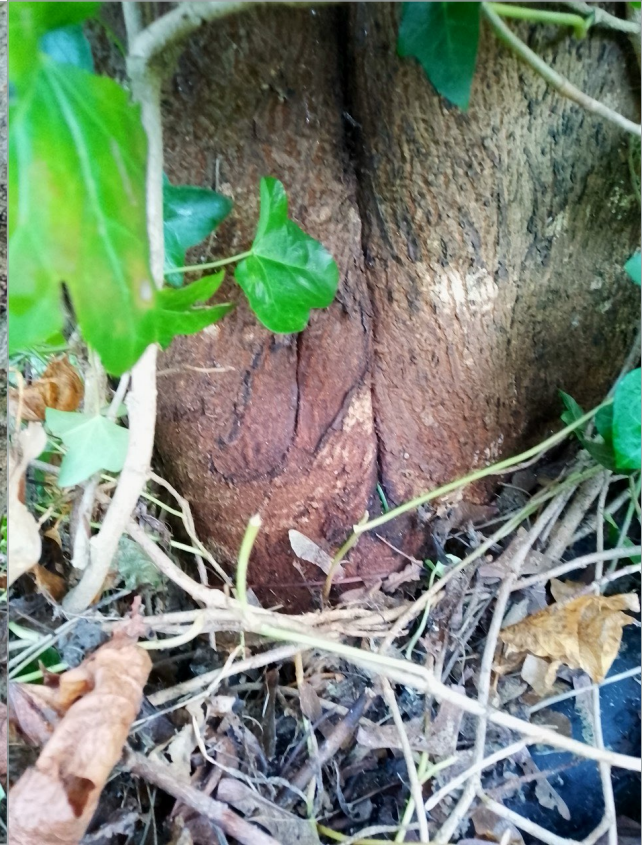
NT15	Norway Maple ( <i>Acer platanoides</i> )	EM	N	POOR Included bark unions from near ground with no fusion.	FELL Remove the tree.	N
<b>Within 24 Months</b>						
552	Common Lime ( <i>Tilia europaea</i> )	M	N	TBD Basal assessment impeded by epicormic growth, epicormic stubs and ivy. Visible parts appear to be intact and healthy, except for an eastern buttress that appears to have some decay.	EPICORMIC Carefully remove the epicormic growth and other vegetation before the next assessment.	P
<b>Ongoing</b>						
2911	Common Ash ( <i>Fraxinus excelsior</i> )	Y	F	MODERATE Possible Ash Dieback infection but still a vigorous and largely intact tree. Ivy growing on the tree.	IVY Manage the ivy.	N
516	Common Yew ( <i>Taxus baccata</i> )	EM	N	GOOD Ivy growing on the tree.	IVY Manage the ivy.	N
519	Sycamore ( <i>Acer pseudoplatanus</i> )	M	F	MODERATE A high crown with reduced vigour. The lower stem appears to be intact. Branches are well attached. Ivy growing on the tree.	IVY Manage the ivy.	N

**Photo 4:** Norway Maple (NT15) with an un-fused included bark union.

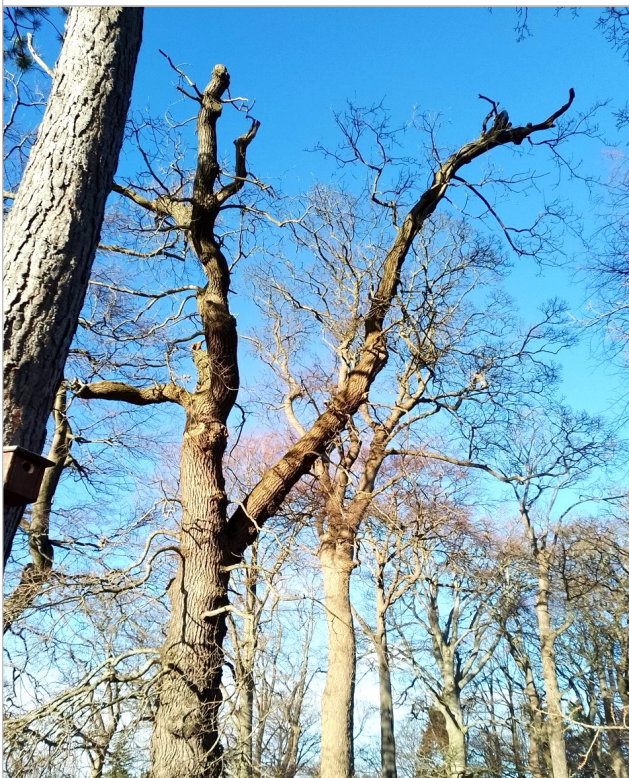
- 3.2.1 A mature Oak (546, area 3) has suffered severe damage to its extremities, likely because of the extent of decay in its upper crown. The remainder of the tree is still fairly intact and healthy, and it is likely to grow a new crown. The northeastern stem has some decay, and could fail onto the boundary fence; it should be reduced in length by around 3-4 metres (Photo 5).
- 3.2.2 A mature Lime (551, area 4) has an end-loaded branch at three metres southwest. It has some large wounds towards the union, and is prone to failure (Photos 1 & 2). This branch should be pruned to beyond the boundary fence, i.e. by around 1.5 to 2 metres.

**Photo 5:** Oak (546) - the northeastern stem is decaying and should be reduced in length.

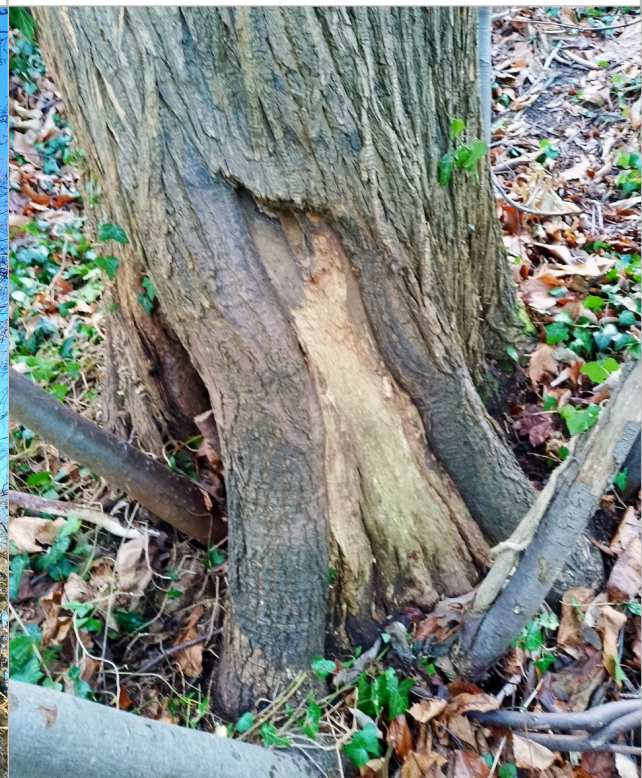
**Photo 6:** Lime (551) - the lower stem should be investigated with sonic tomography.

- 3.3.1 A mature Lime (551, area 4) has some basal wounds with cavitation on its north and east sides. I recommend that a sonic tomography investigation is commissioned in order to determine the density of the internal wood (Photo 6).
